Fire extinguisher bottles aren't much good if they can't hold a charge. But leaking bottles are exactly what some Bradleys and MLRS carriers are carrying.

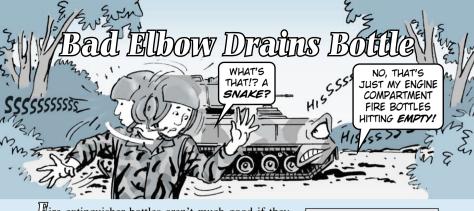
Between Sep 99 and Feb 00, some FM 200 engine compartment fire bottles, NSN 4210-01-463-0807, came equipped with a defective elbow on the valve. The elbow allows a slow leak that eventually empties the bottle.

If your vehicle had new fire bottles installed during those 6 months or if you're unsure when the bottles were installed, check them now.

If you've got a bad elbow, contact Windell Bishop, Red River Army Depot's customer service representative, at DSN 829-4816, (903) 334-4816 or (800) 442-0816 to arrange for a replacement elbow.
